MEMORANDUM

Macon County - LPC 11580408 - Decatur/Macon County #2

The Macon County Landfill site was inspected on April 18, 1979 by John Taylor. The purpose of the inspection was to determine the site's suitability for the continued acceptance of special wastes. The site was observed to be in violation of the Act, the Rules, and certain conditions of the permit at the time of the inspection. The conditions observed at this site warrant the denial of any future applications for supplemental special waste permits for several reasons.

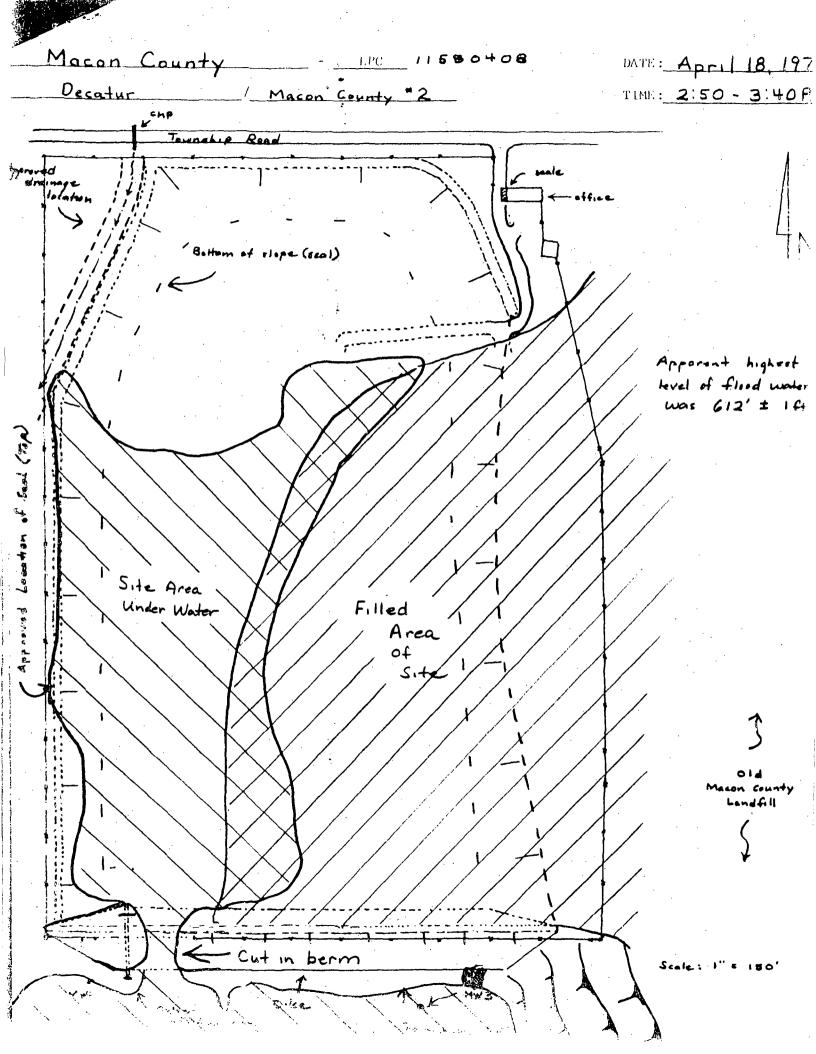
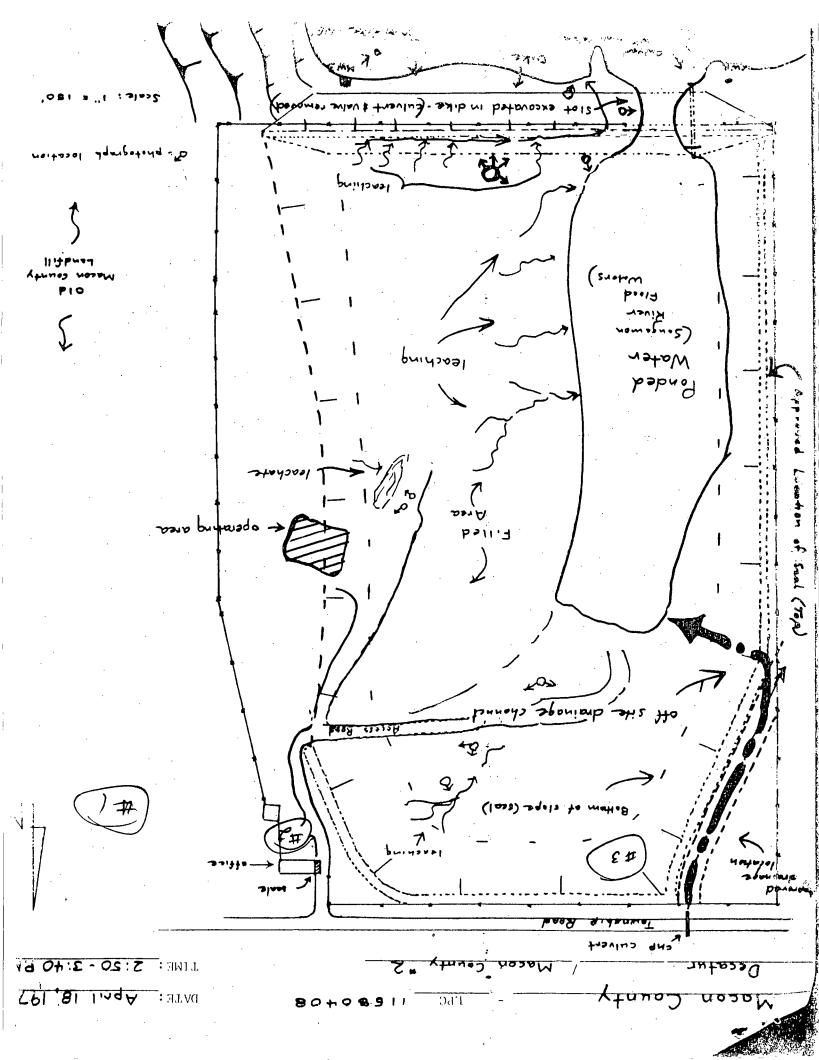
The "Hydrologic and Geologic Report", submitted as part of the original permit application, casts doubt on this site's suitability for disposal of special wastes. The attached chart, adopted from soil profiles in this report, show that there is a great deal of sand and silt present that will necessarily have to be used for daily and intermediate cover. Once site development reaches the point at which the drainage culvert under the dike is properly plugged and sealed this might not be a major concern. At that time all contaminants would be contained within the seal and the dike. However, until that point is reached, any liquid build up in the filled areas may easily flow through the porous cover materials, drain into the surface water drainage channels, and leave the site through the culvert. This situation appears to have existed for several years. According to the permit, the seal along the north and west sides of the site will not be constructed and the culvert, if it still existed, would not have been plugged until late in the life of this site.

Subject	Macon County - LPC 11580408		
	Data	Decatur / Mason County #2	_	
	Reviewed by	•	Date	April 18, 1979
Borini	g Number:	1 2 3		7
ileva-	hen			
638		Surface elevation		
34			\$ 1.1.	
34		B-own M	1	Sands
32		Clay		
6 20				S.1+s
20	.	headfur mu	· · · · · · · · · · · · · · · · · · ·	
26				
24	, :	Side		
22		Cilty		
620				
iŝ		Brown Clayey Brown		
16		light graft well granded	t 1	
14	. •	South & Brown		
12		blade manife solly		
610		- H H -		
68		black H Brown Brown		
04		s.ity	#	1 .
04		nguister 11 ngus		Brown 3,1ty
62	L	Sand Sand		the sand & gravel
600				
91	B ·	chayer		grayey brown silty clay
90	´ .	The state of the s		arry cmy
94				gray
92	·			trace sand & gravel
510		- L		Fray sity clay
8		Gray silty clay, end of		gray medium dense
80	4	of ////////////////////////////////////	///	clayey silt
8,		- Inning / / / / / / / / / / / / / / / / / / /	///	
83	2.	End ////	///	
5 8	•	of bering	///	
78			///	
. 70			///	
7'	4		///	545.5
